TRIP ODOMETER REPAIR – ANALOG DASH

Buick Regals built between 1984 and 1987 were fitted with analog dash displays, 85MPH, as a standard dash setup. The analog dash cluster utilized a mechanical cable-driven speedometer, odometer and trip odometer with an integrated reset button. The trip odometer is ordinarily reset to all zeroes with the button, and will accumulate trip mileage until it is reset again.

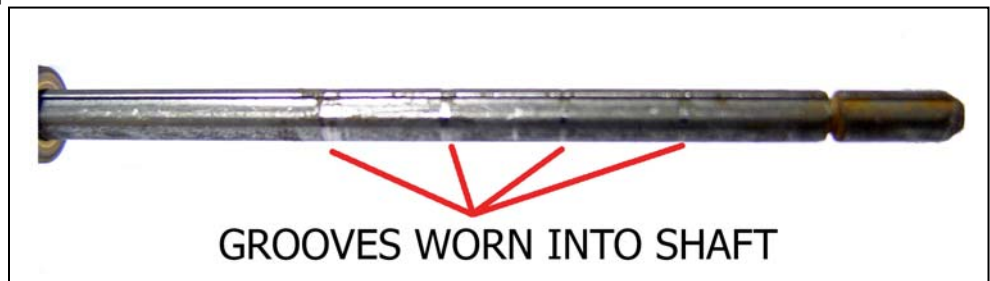
Part of the problem with the trip odometer relates to factory design; most of the internal parts in the odometer assembly are plain, un-plated steel. The steel pawl springs inserted between the wheels tend to rust due to moisture in the air, causing excessive wear to the grooved reset shaft, which is also un-plated steel. The wear is seen in the form of four radial grooves into the grooved reset shaft, causing the pawl springs to jump over the reset groove in the shaft, preventing the digit wheels from parking in the ZERO position once the reset knob is pressed.

Trip odometer reset shaft with number wheels removed. Note the damage caused by excessive wear.

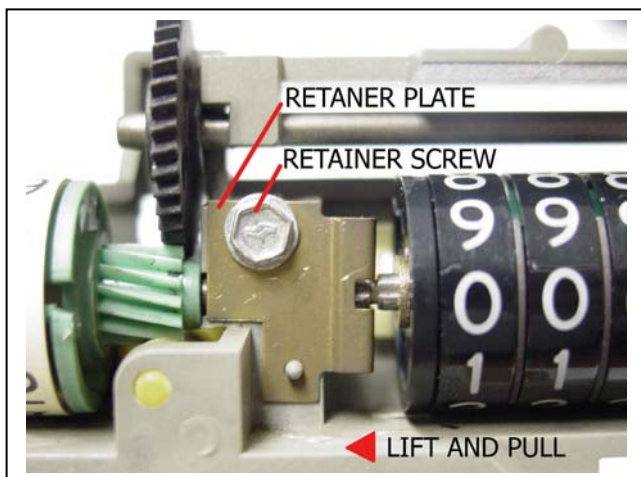
The trip odometer will be disassembled and repaired. First, remove the speedometer cluster from the vehicle, and remove the faceplate from the mechanism to reveal the speedometer and trip odometer. You will notice a small screw that holds the trip odometer in place, along with a brass retaining plate. Remove this screw and carefully remove the retaining plate. Carefully slide the trip odometer movement to the left while lifting the assembly up and away from its frame. The odometer movement can then be inspected and disassembled. You can now remove the seal and take the assembly apart.

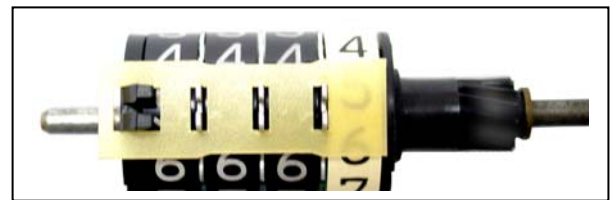
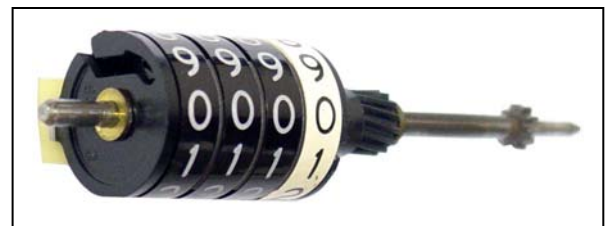
Use extreme care when removing the plastic seal. This is very fragile and can break easily! Lift it away from the assembly evenly and slowly.

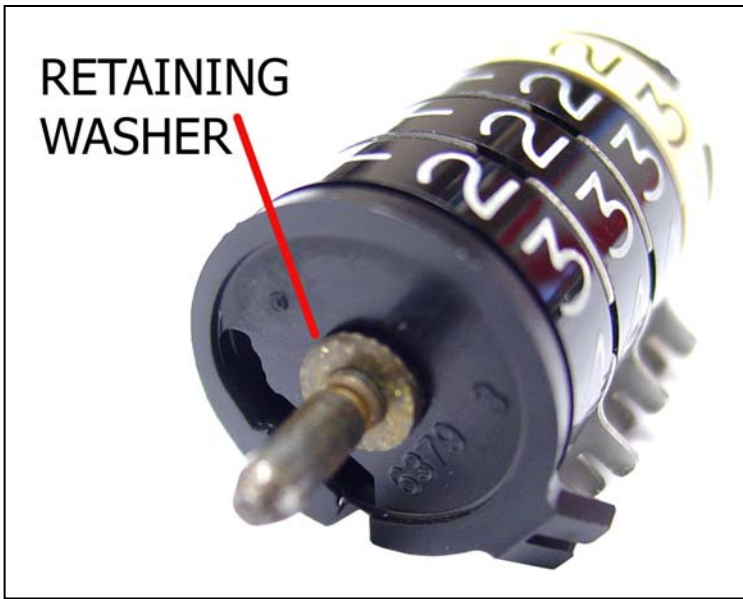
Once the trip odometer is removed, the brass retaining washer on the end must be removed. This washer is used to hold the number wheel assembly together and is press-fit onto the end of the shaft. To remove this washer, you must gently pry under the washer to lift one end, then wiggle the washer to loosen it. Use a miniature pair of fine jaw pliers to gently wiggle and loosen the washer to remove it from the shaft.

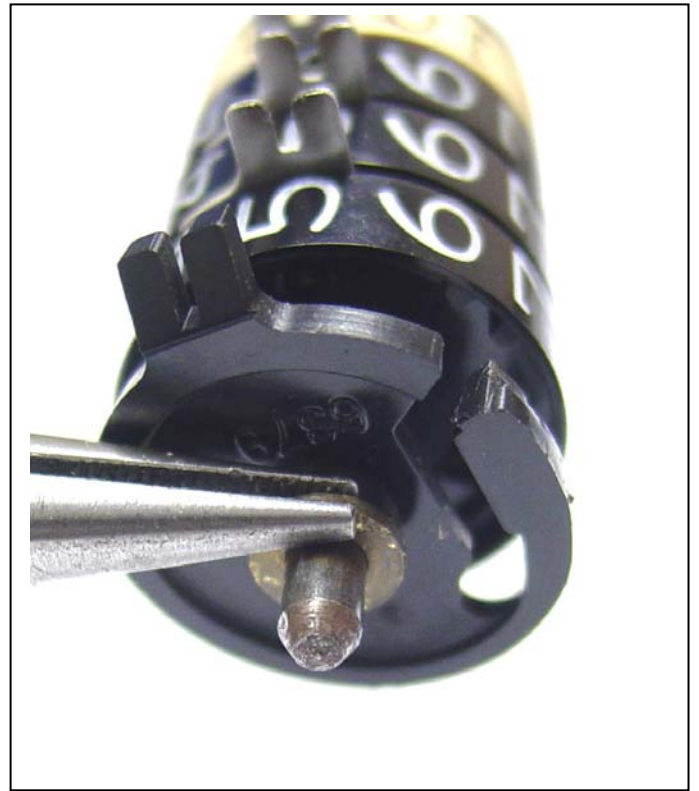
Loosen the retaining washer enough to grip it with a pair of pliers, then slide it off the end of the shaft.

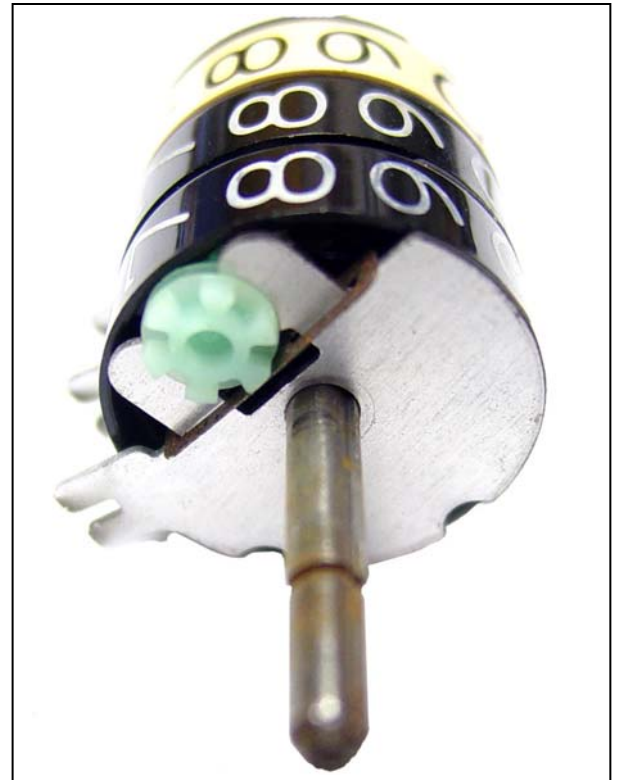
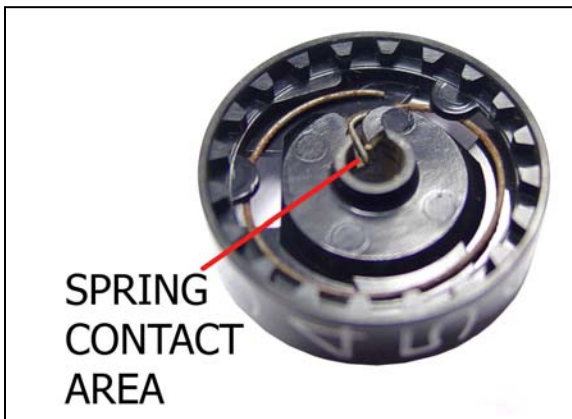
Very carefully remove each part of the assembly, being extra careful to keep the order in which the parts are assembled. The metal plate between each number wheel has a small gear placed into a slot on the plate. This gear must be kept in its original place and can't be reversed on the plate, so take note as to how the gear is positioned on the plate.

Note that the gear on each plate is suspended within the groove by a small flat spring. The gear has regular teeth on one end, and interrupted teeth on the other end. Be sure the gear stays in the plate as seen here.

Carefully remove each number wheel and spacer plate, and keep them in the same sequence that they were originally.

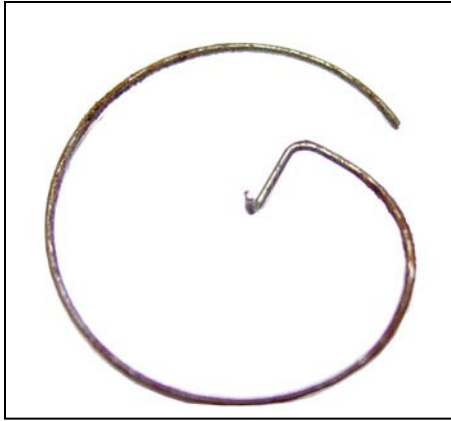
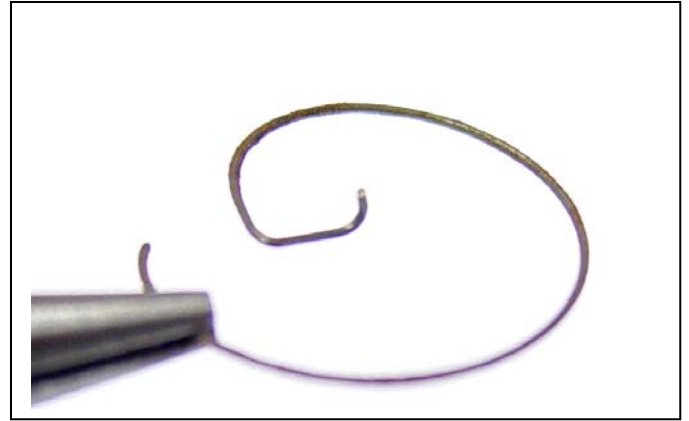
Observe the number wheels. Each wheel has an elliptical spring inside it. The end of the spring has a pawl that drops into the inside center bore of the wheel, which contacts the grooved shaft. This pawl acts as a one-way clutch that enables the shaft to rotate counter-clockwise freely and lock the wheel when the shaft is rotated clock-wise. Occasionally, the pawl loses its spring contact with the shaft. When this happens, the wheel does not lock into the zero position when the reset button is pressed, causing the wheels to be out of sequence. This pawl contact, in addition to the wear on the shaft, is the reason the trip odometer fails.

The end of the spring is curved upward and this is the area that contacts the grooved part of the shaft. This is what keeps the number wheels at zero when they are rotated by pushing the reset button.

The object of the repair outlined here is to re-position the contact area on the shaft and re-align the contact point of the spring pawl. Remove the spring from the number wheel and inspect it. Note that the contact area of the spring tends to be slightly crooked once it's installed into the wheel. By gently bending the pawl area, you can re-align the end of it, providing better contact to the grooved shaft.

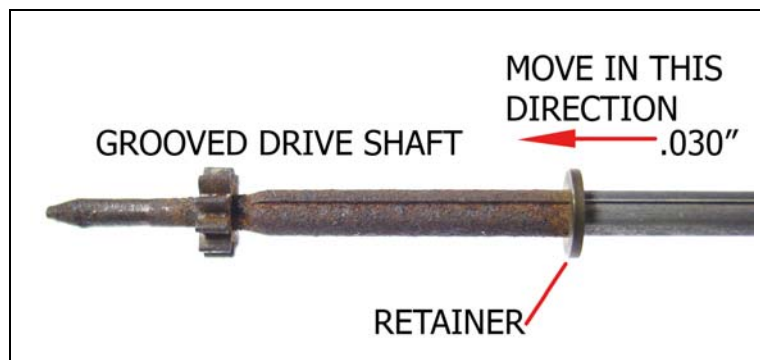
Next, we are going to reposition the inside retainer washer on the shaft. What we want to do is move the retainer washer about $1/32''$ or $.030''$ further down the shaft. The effect of this is to move the contact area of the pawl away from the original worn out area, to give it a new spot on the shaft to contact. One reason the wheels don't reset properly has to do with the wear on the grooved shaft, and the other reason is the pawl spring losing its tension and/or wearing slightly.

To move the retainer, use pliers to wiggle it slightly to loosen it on the shaft. Be very careful to do this a little at a time, since you are most likely moving it to a rusty part of the shaft and you don't want to loosen it too much – it must be tight against the shaft once it's repositioned. If the retainer is too loose, it can slip and cause misalignment of the number wheels.

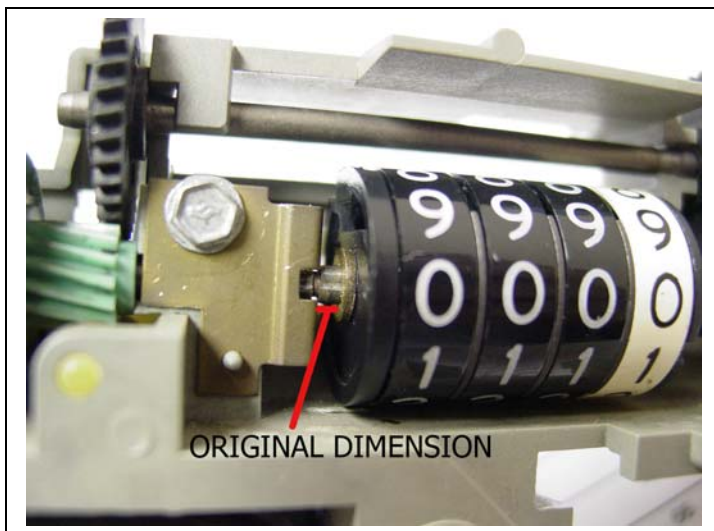
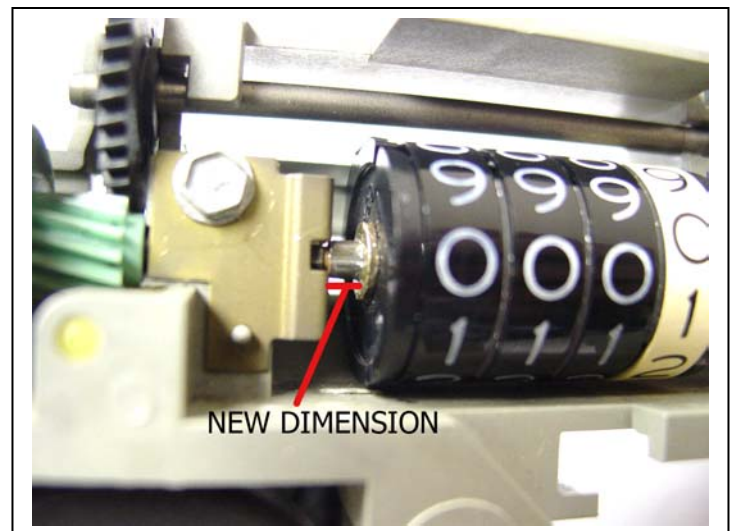
Now that once the retainer is repositioned, the trip odometer wheels will be slightly moved to the right. However, it will still be fully visible in the window cut into the dash faceplate. The difference in alignment is the 1/32" shift on the position of the locking washer stop.
