TECHNICAL INFORMATION

Grand National – T-Type Analog Dash Cluster Tach/Boost Gauge -- GM Part Number 25077018

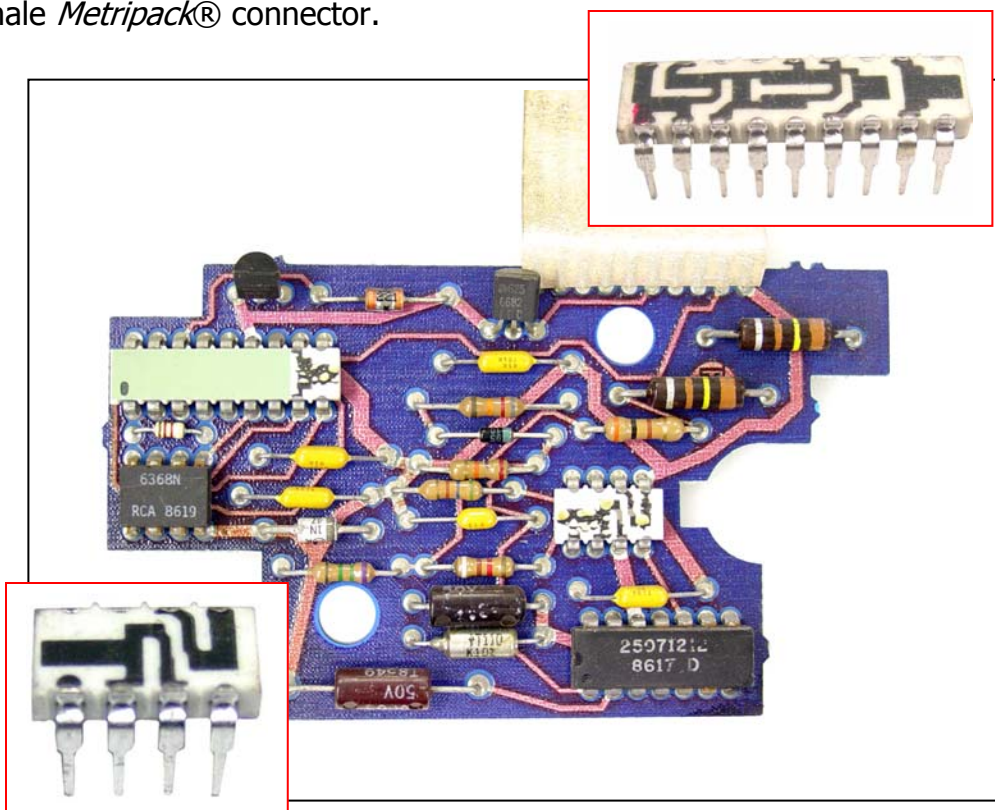
This is the middle PC board which has the custom resistor network chips. The chip that controls boost is the larger chip in the upper left corner with the green top. The chip that controls the tach is the smaller white top chip in the center right.

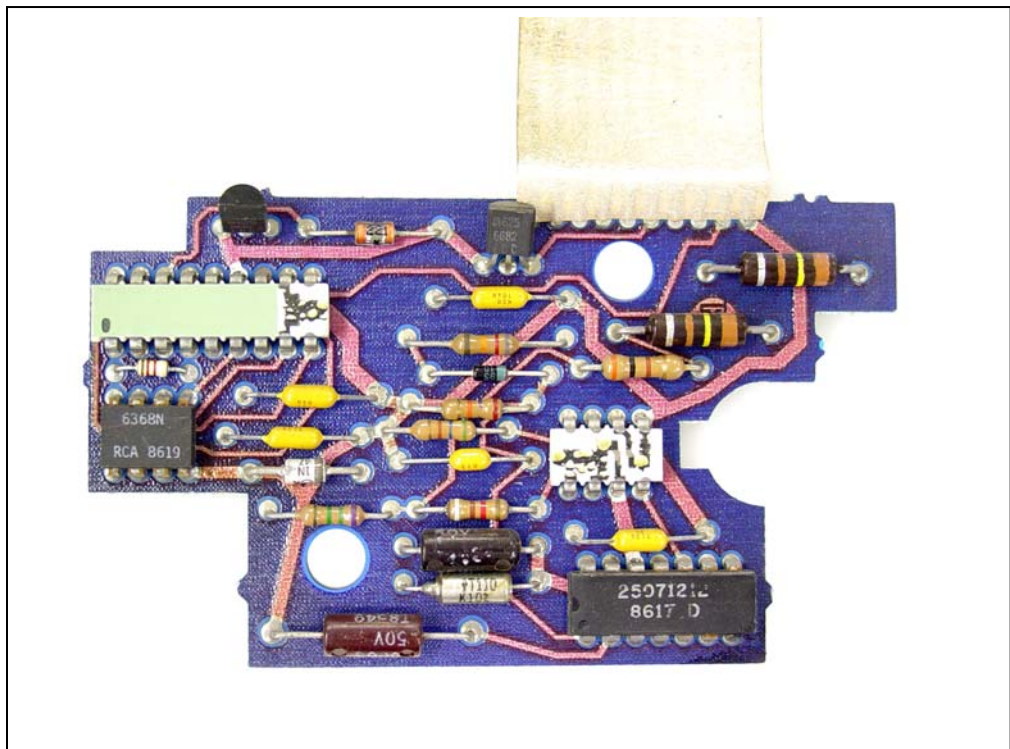
The deterioration to these network chips can be seen here. Look closely at the two calibration network chips; you'll see blistering on the carbon traces in the un-protected areas of the chips.

This happens because the carbon traces are exposed to air, moisture, and pollutants in the air. The carbon elements heat slightly during normal operation and when they cool, tend to collect slight amounts of moisture and salt deposits (particularly in climates near salt water). The effect causes the carbon to de-compose, leaving oxidized traces on the ceramic substrate of the network chip, and increasing the resistance to place the circuit completely out of calibration. We have also observed oxidation and conductive growth within the laser-etched area of the calibration slots.

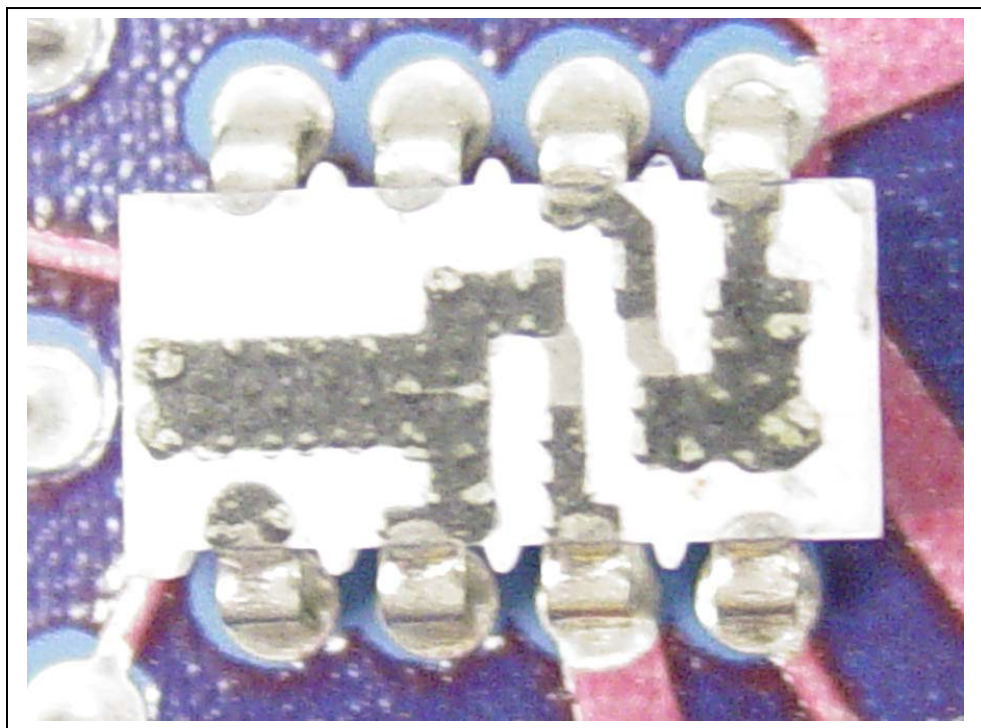
Here is a closer look at the surface damage on the carbon traces of the network chip. Notice the bubbling areas where oxide has formed, changing the resistance of the carbon patch areas.

This problem seems to happen fairly consistently with the age of the vehicle. It now appears to be a very common problem that eventually will happen to each and every turbo car fitted with this display. The tach section seems to be more prone to failure than the boost readout, and for an obvious reason. If you look at the larger boost control network chip, you will notice that most of the carbon traces on the ceramic substrate are coated with a green paint-like coating. Only the critical calibration resistance pad is exposed.

The tach control network chip (the smaller one) is fully exposed and prone to much more deterioration than the coated chip. Because these network chips weren't coated with any type of paint or sealant after calibration, they became prone to moisture damage. This is why the failure rate on these components is so high. And considering how it happens, it is likely that the failure trend will continue.

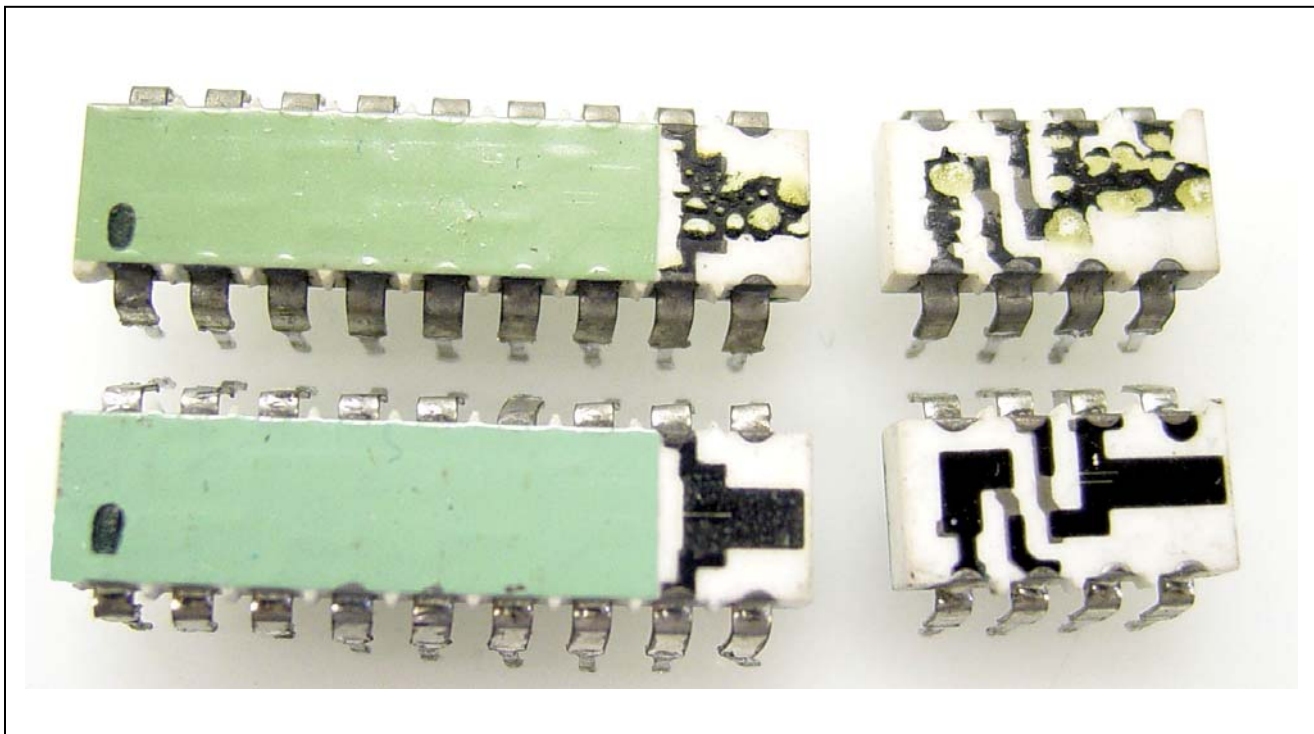
Here is a "before and after" view of these chips

The repair and recalibration involves replacing both network chips, then recalibrating both the boost and tach sections of the module on the bench using a calibration standard. The calibration is performed using a diamond cutting tool instead of a laser, since the diamond tool doesn't exhibit extreme heat in the region of the resistor pad. The chips are then fully sealed with a coating after the calibration process.
