# TECHNICAL INFORMATION

## Turbo Buick 3.8L Crank Sensor

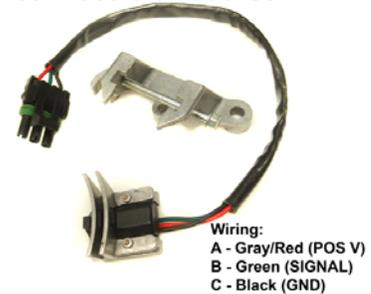
1984-1985 Crank Sensor

The 1984/1985 sensor was identified by the extended casting on the pickup end along with the attached pigtail and Weatherpack connector. Note that GM used the green wire as a signal wire, black as a ground, and the gray/red stripe wire as a positive feed for the sensor. **This color code is the standard GM protocol.**

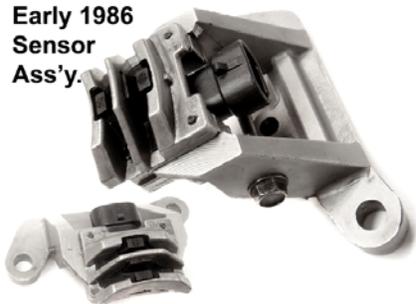
Early 1986 Sensor Ass'y.

Early production 1986 vehicles used a modified version of this sensor with a Metripack molded-in connector. This design used the same mounting bracket from the original design. However, this version was prone to failure due to loosening of the components which were responsible for holding the sensor into place.

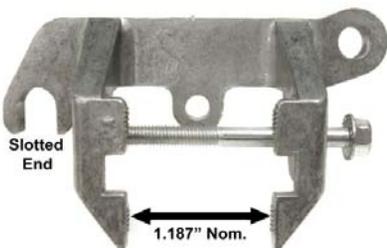
Late '86 to 1989 Sensor Ass'y.

Here is the current design using a smaller sensor and narrower bracket. The narrower bracket simplifies design, reduces part count, and minimizes failure due to loosening mounting components. With this design, the sensor stays in place and is less prone to loosening.

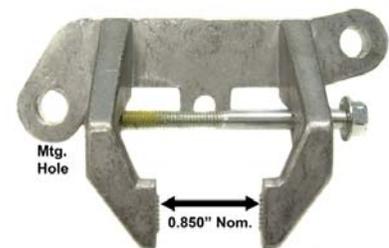
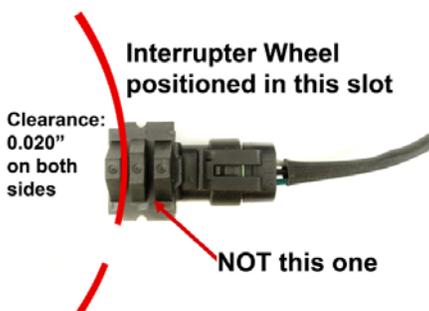
1986-1989 turbo Crank Sensor

Note the difference between the early design bracket (left) and the current design (right) using the narrower mounting jaws.

Important details when installing the sensor: Interrupter passes thru slot that's furthest from the connector. Also, note wire colors for 1986 and newer: The green wire is now the positive feed and gray/red wire is the signal – different than the 1985 color specification and no longer conforms to the standard GM protocol for wiring designations.
