INSTALLATION INSTRUCTIONS

102050 Battery Negative Cable – 1989 turbo Trans-Am

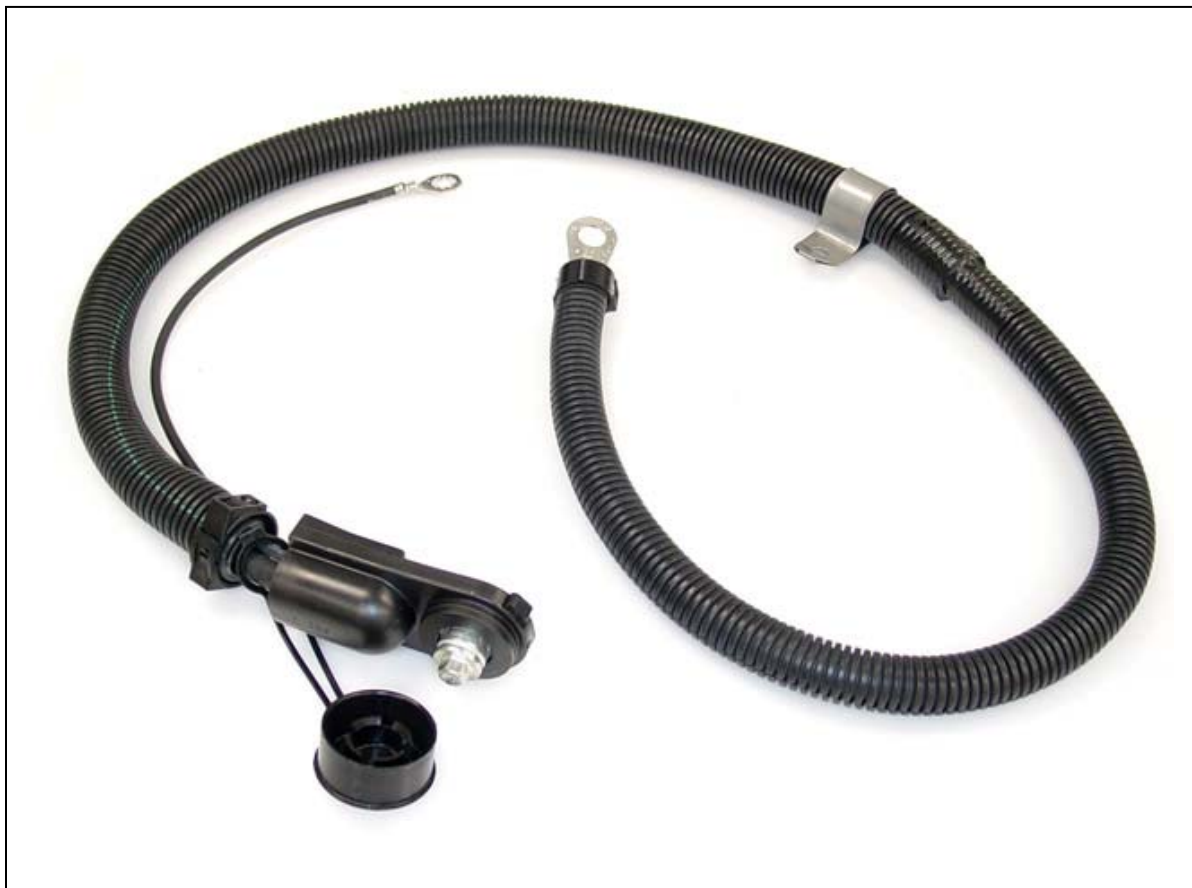
Factory replacement battery negative cable fits correctly for your turbo Trans-Am application. All critical lug connections are crimped and soldered to ensure reliability. Also includes center harness support clamp.

This cable attaches to the turbo support bracket and includes a short pigtail which must be securely attached to the inner fender well ground bolt. This assures proper chassis grounding. Be sure all attachment points are securely tightened.
