TECHNICAL INFORMATION

Electronic Air Conditioning – Digital Climate Control Option

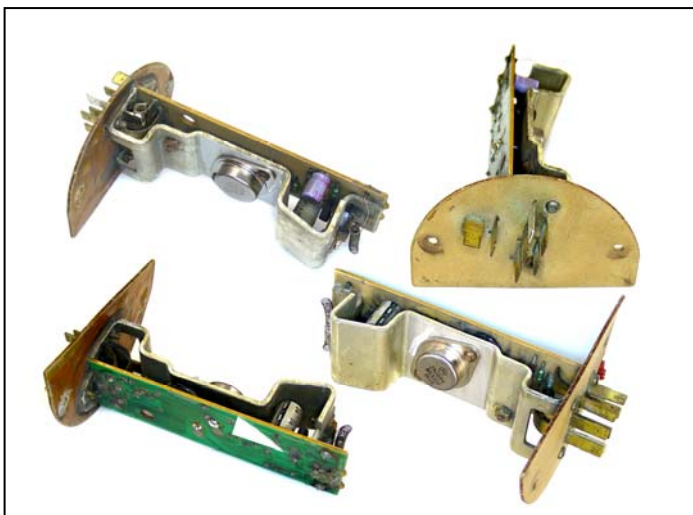
RIGHT: Control Head front and rear views

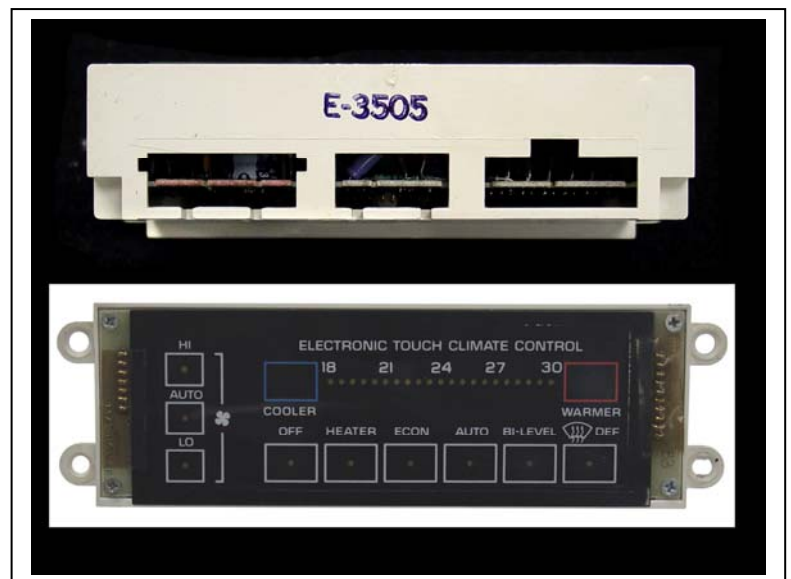
This article deals primarily with the Blower and A/C Clutch Control Module located on the heater enclosure under the hood, secured by two screws. There are two connectors plugged into the module; one 5-terminal and one 2-terminal connector. These are situated in such a way as to retain moisture, causing a failure due to corrosion. Caspers has re-designed this module, Part Number 107146, with a different connection design to overcome this design flaw.

BELOW: Blower and AC Clutch Control Module

Upon removal of this module, you can clearly see the effects of corrosion and intense heat damage. The module uses high power transistors as a means to control the compressor clutch and the blower motor, and these transistors produce a great deal of heat in the process. The heat generated reduces the life of the component, causing component fatigue and electrical failure.

Before installing the Caspers replacement module, inspect the original connector for signs of corrosion and overheating. Repair this connector before installing the new module as damaged terminals will not provide a proper connection. Contact cleaner is not adequate to restore a corroded terminal; replace the terminal when any signs of corrosion are evident. **The Caspers replacement module is supplied with a separate battery feeder that attaches directly to the battery, to overcome the design flaw of the original module – burned feeder terminal on the module.**

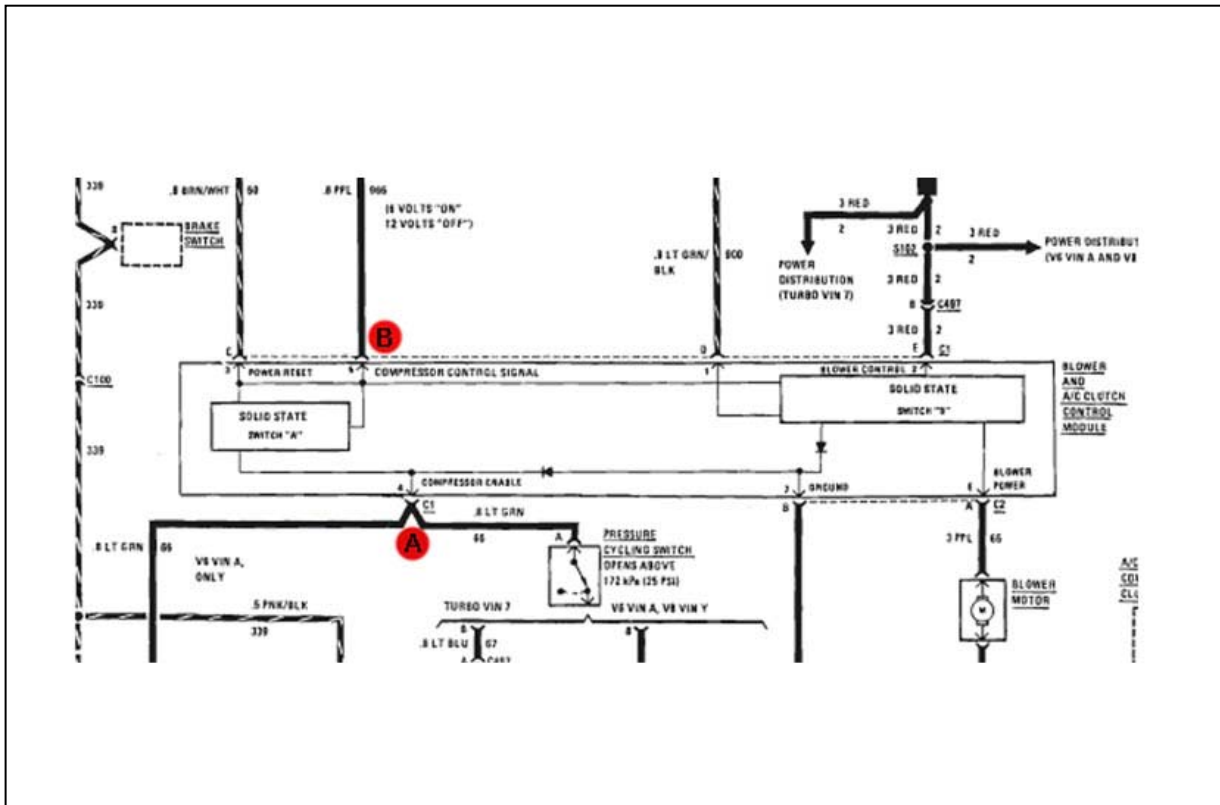
When using the service manual for troubleshooting, be aware of the incorrect pin assignments shown in the original schematic of the Module. The factory manual showed A and B of this wiring diagram incorrectly swapped. The correct designation is shown below in red:

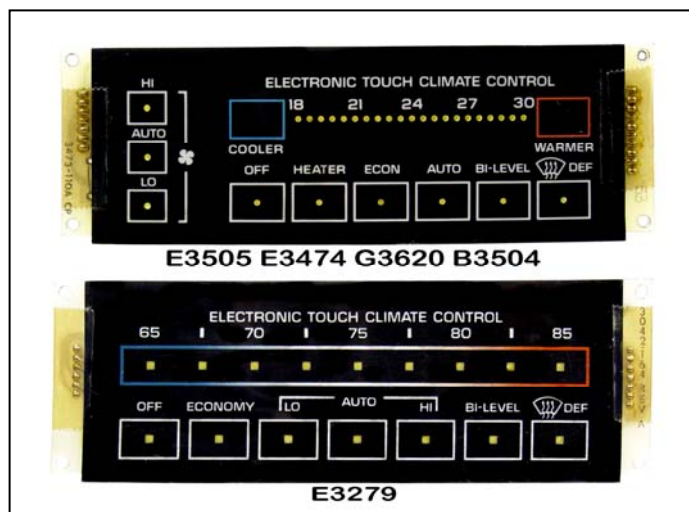
Shown below are two variations of GM control heads. These have been in use from 1983 thru 1988 on the B, C, G, E and X body cars and there are dozens of different part numbers in use. They are occasionally interchangeable; however, some functions (such as DEFROST) may not be functional on certain control heads. Be sure to locate the same part number when replacing the control head.
