# INSTALLATION INSTRUCTIONS

## 107149 C100 Dash Connector Sealing Gasket

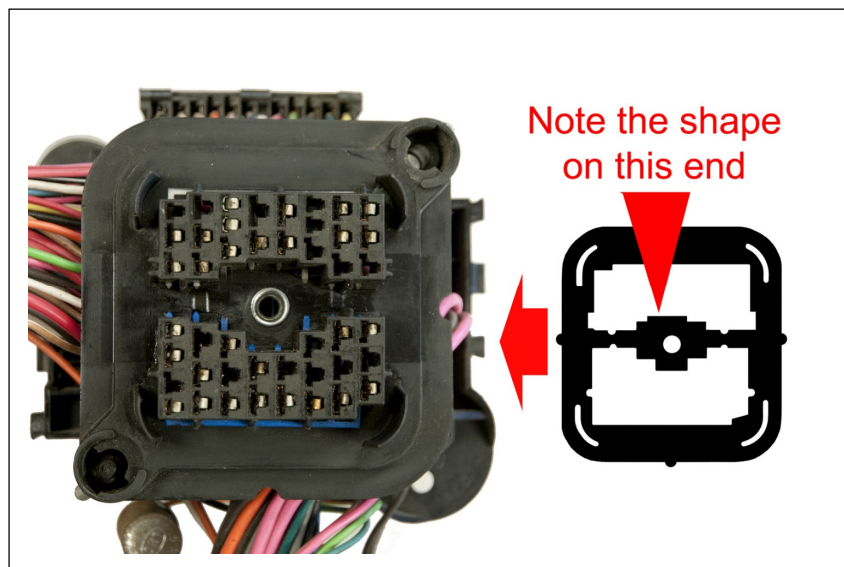
Remove all traces of the old gasket and clean the surface. **Now would be a good time** to inspect the terminal connections and clean the tar sealant off. Use white lithium grease to replace the sealant. Replace any corrosion-damaged terminals as cleaning them won't fix the damage. Position the new gasket as shown in the image below. Note that the gasket must be correctly installed due to the slightly irregular dimensions of the connector. Once gasket is in place, reverse this procedure to finish the installation.
