INSTALLATION INSTRUCTIONS

102025 Battery Positive Cable – 1989 Pontiac Turbo Trans-Am

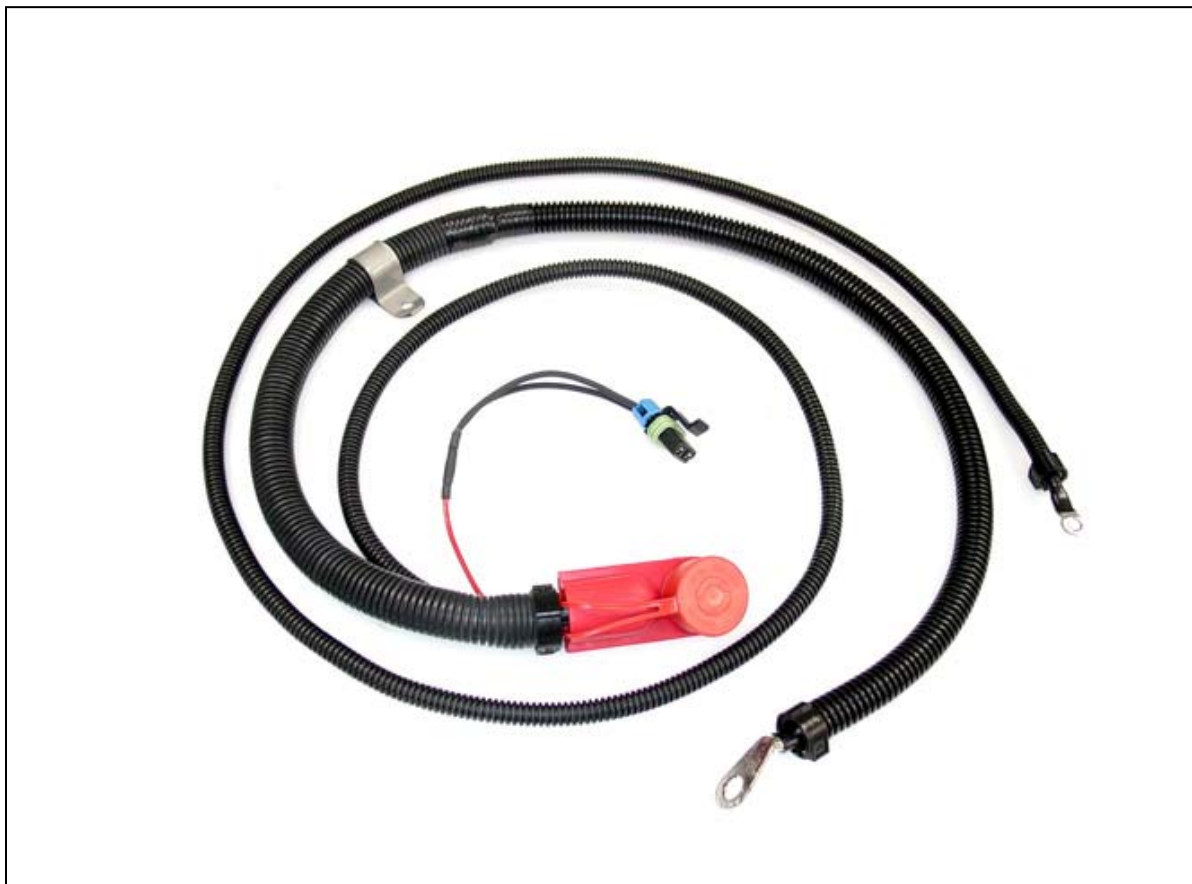
Factory replacement battery positive cable has alternator feed, starter feed and ECM MEM feed. Furnished with protective bolt cover. OEM wire gage and sizes are used throughout. All critical lug connections are crimped and soldered to ensure reliability.

Be sure cable does not contact hot exhaust pipes as burn-thru may result in electrical shorts. Make sure all connections are tightened securely.
